ELK-M1 CONTROL RELEASE NOTES

December 2, 2025 - M1 Firmware 5.3.36 – UL Listed

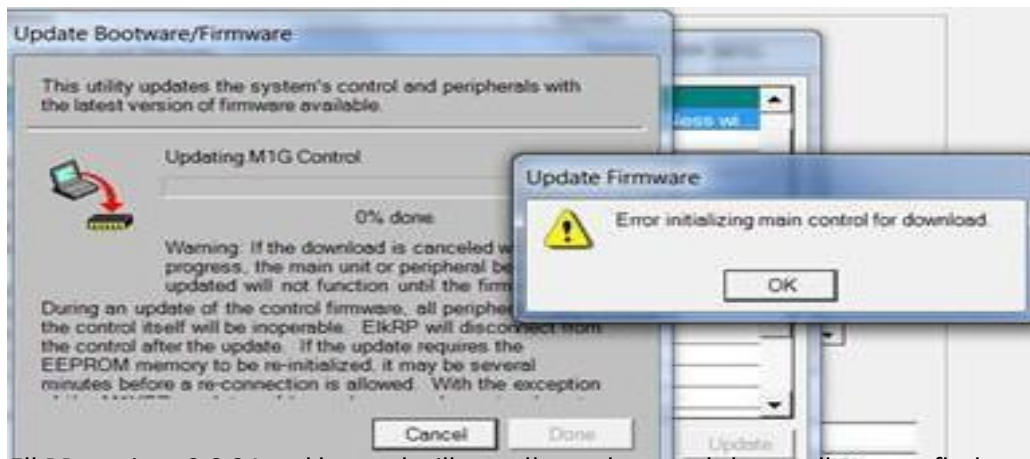
ElkRP versions 2.0.24 and beyond will not allow a bus module enrollment or flash memory update to be performed if any area is armed. To enroll or do a flash update it will be necessary to disarm all areas, do the enroll or flash update, then re-arm. This change was implemented in the interest of enhanced security. The warning or error message displayed will depend on the version of ElkRP that you are currently using.
