ELK-M1 CONTROL RELEASE NOTES

June 15th 2026 - M1 Firmware 5.3.42 – UL Listed

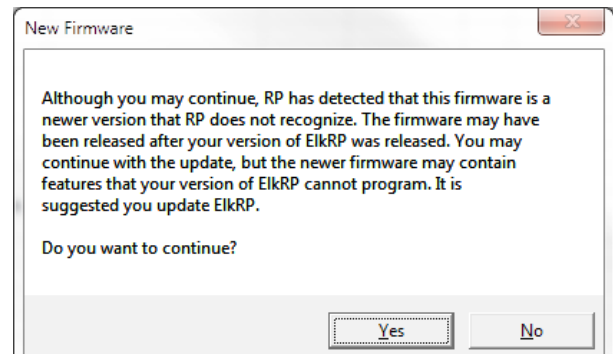
This “New Firmware” message may appear upon connection if ElkRP does not recognize the new version of M1 firmware. There is no great need for concern. This is generally just a case where ElkRP has not yet been updated to reflect the newer M1 firmware version.

ElkRP versions 2.0.24 and beyond will not allow a bus module enrollment or flash memory update to be performed if any area is armed. To enroll or do a flash update it will be necessary to disarm all areas, do the enroll or flash update, then re-arm. This change was implemented in the interest of enhanced security. The warning or error message displayed will depend on the version of ElkRP that you are currently using.
